Halo Home
Inspections

Home Inspection Report

12345 Resale Ave
Maricopa,, AZ 85138.

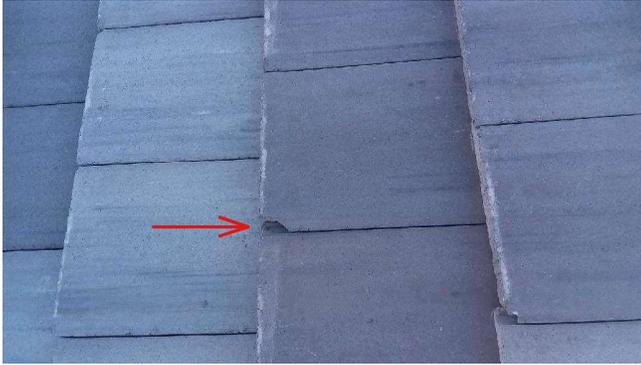
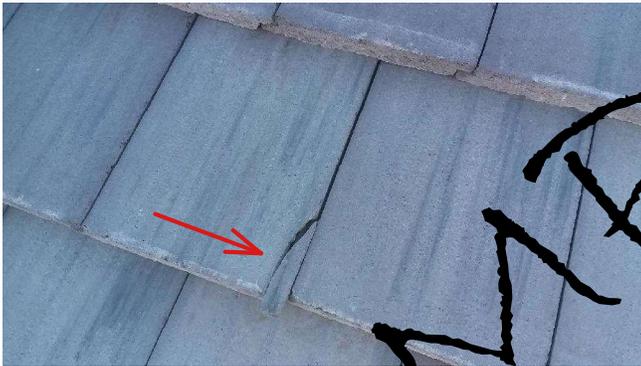
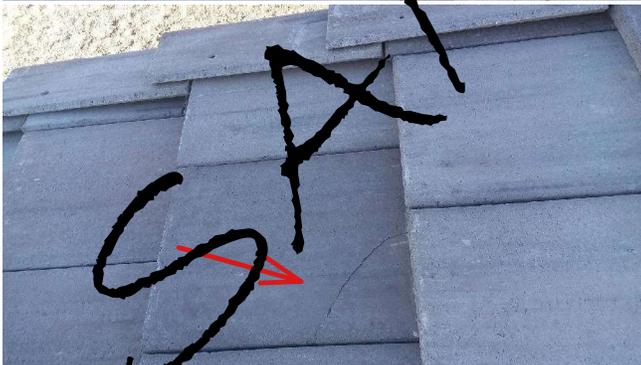
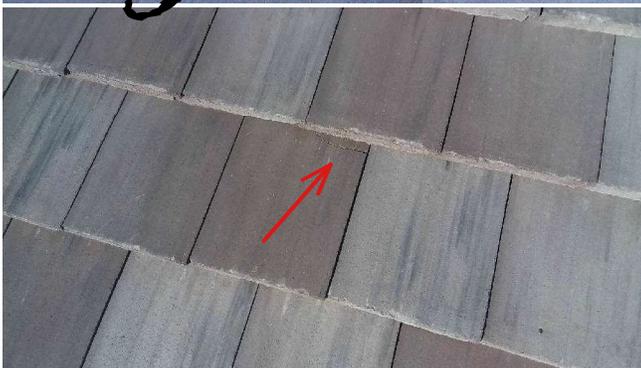
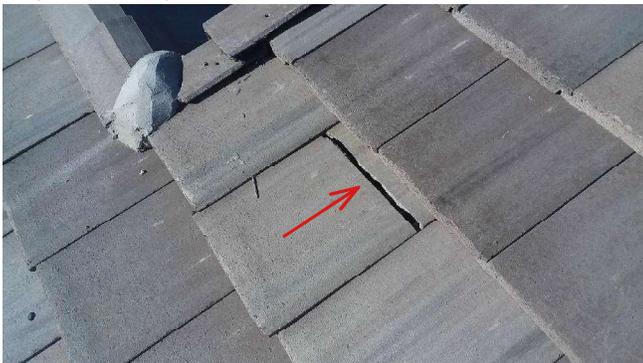
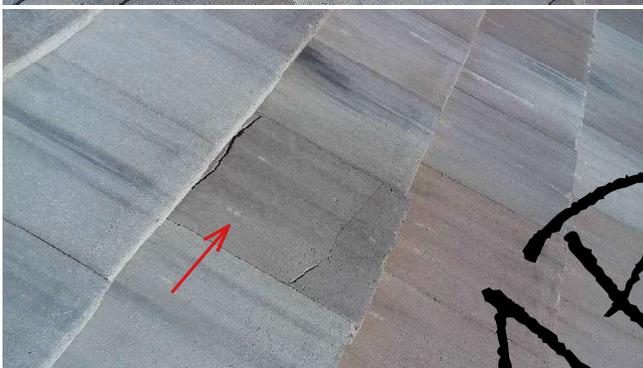
6. Roof Conditions: Repairs necessary. - **Loose/displaced/damaged shingles were found in one or more location. Recommend evaluation and any necessary repairs by a qualified professional.**

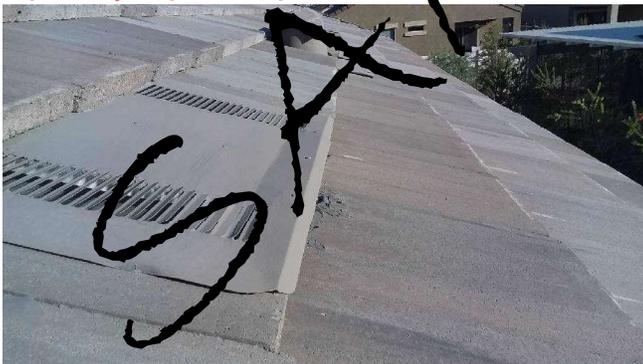
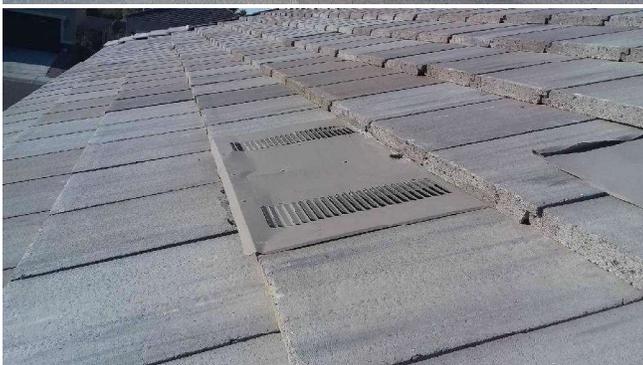
7. Roof Venting: Gable vent., Covered roof vents. **Vent hood is dented / damaged. This may allow for ponding and moisture penetration at damaged louver. Recommend evaluation and any necessary repairs by a qualified professional.**

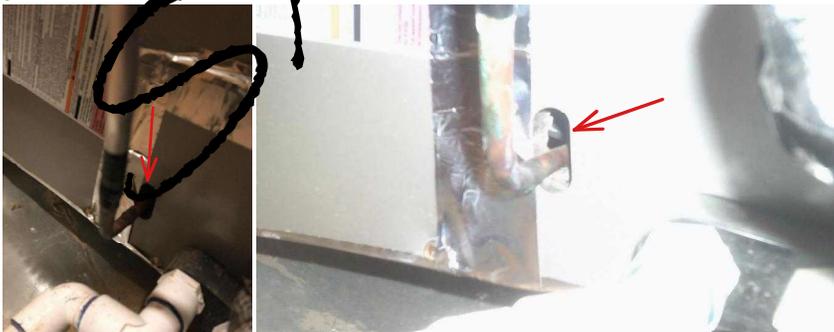
14. Devices: Furnace / air handler Cabinet. **Holes / openings in cabinet noted. Allowing conditioned air to escape into attic location. Recommend evaluation and any necessary repairs by a qualified professional**

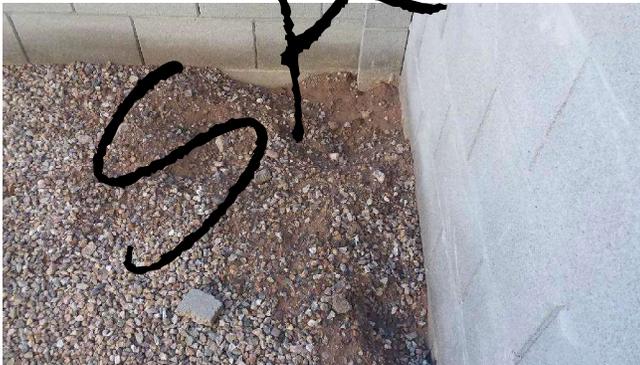
14. Grading(22): Minor slope. **One or more sinkhole(s) / Low spots were found. Recommend dirt be added to prevent pooling and further erosion. This promotes foundation deterioration and pest intrusion and needs correction and monitoring. .**

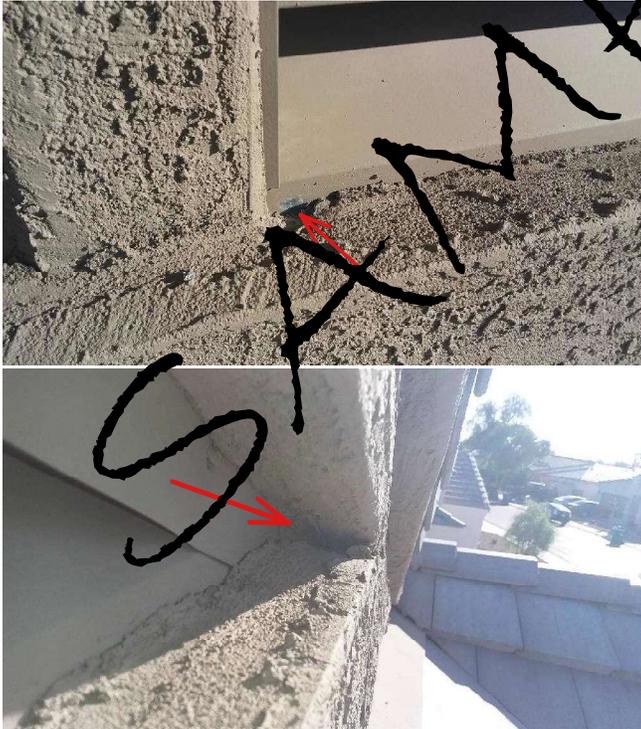
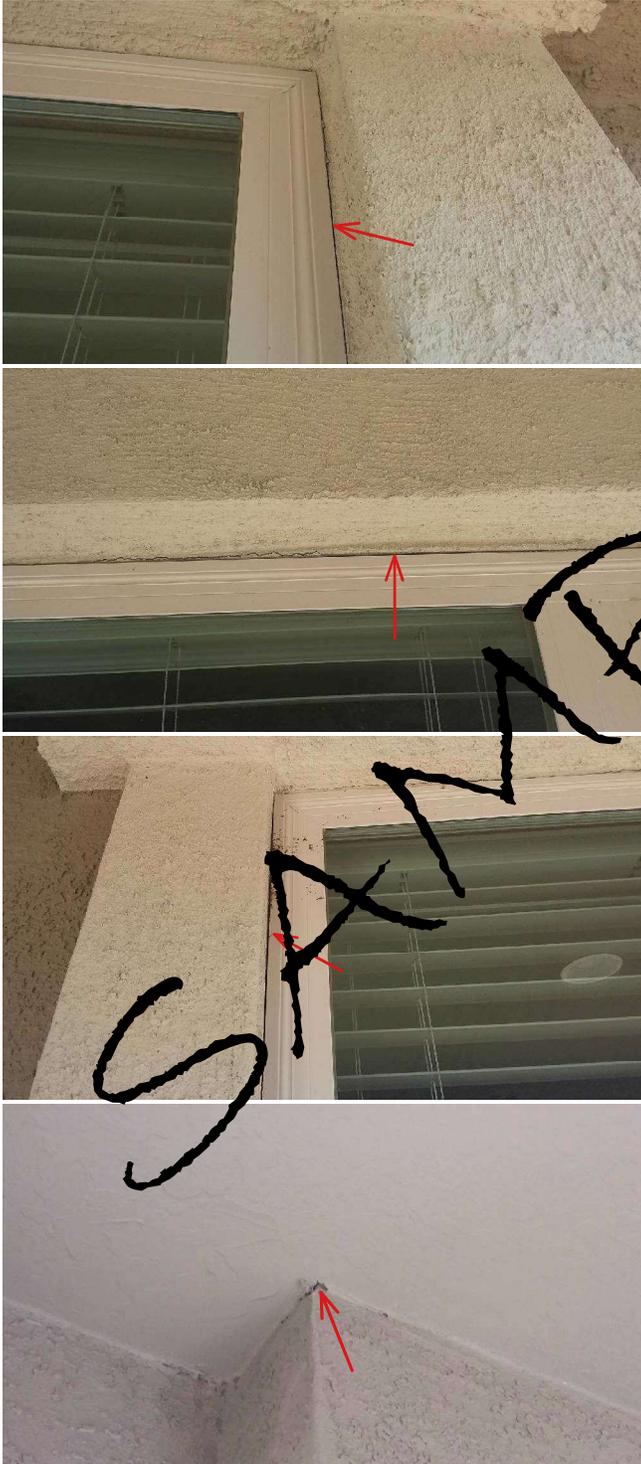
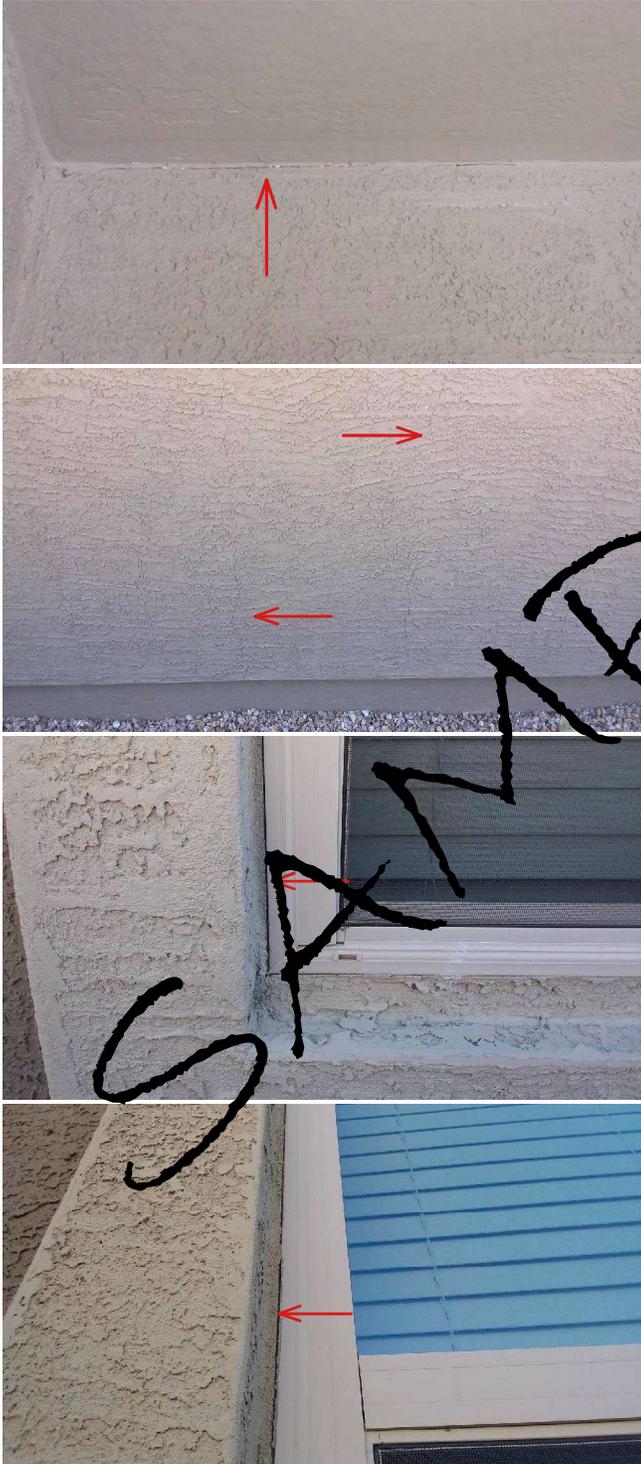
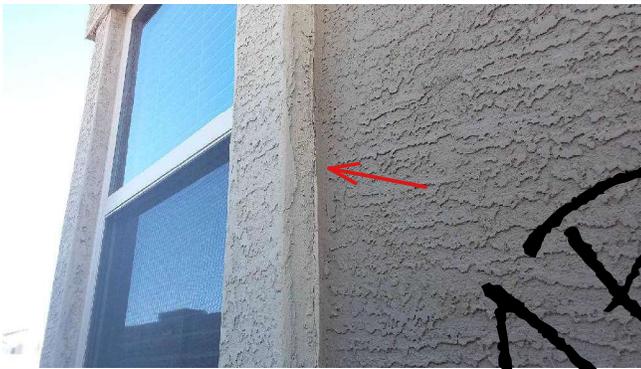
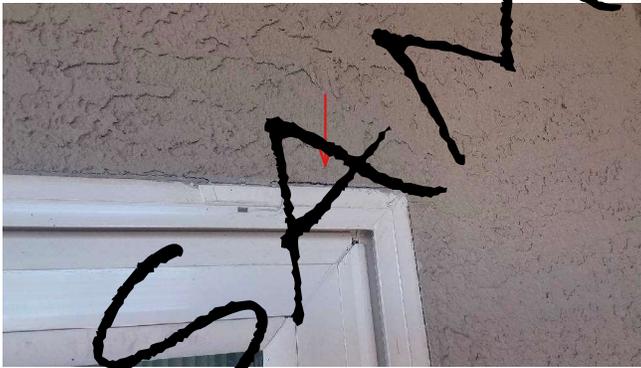
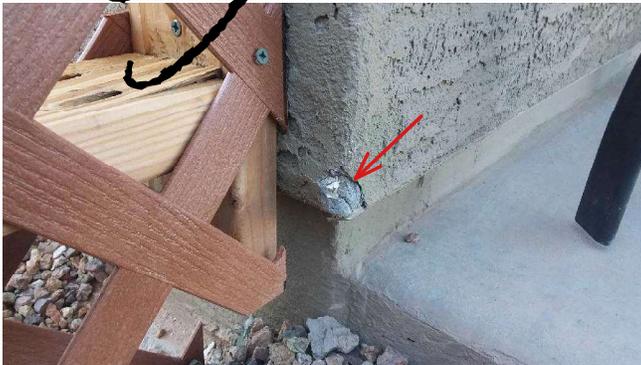
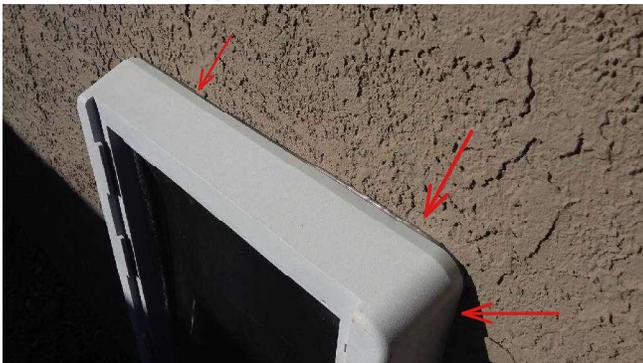
7. Cladding Conditions: Multiple conditions noted. **Cracks and openings in need of repair to prevent water and pest intrusion. Dog door was not properly sealed during inspection and may allow moisture penetration. Signs of premature settlement cracks noted. Recommend evaluation and any necessary repairs by a qualified professional.**

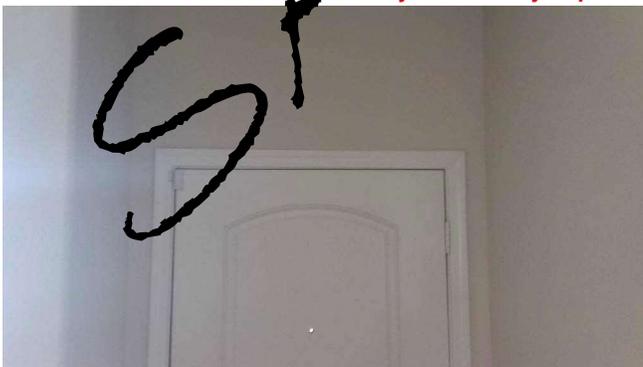
14. Entry Doors(15): Metal, Wood, Glass. **Settlement noted around trim and door is Unlevel in frame. Recommend evaluation and any necessary repairs by a qualified professional.**

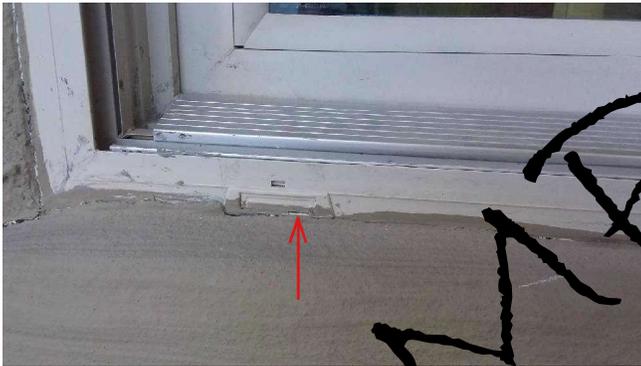
15. Patio Door: Sliding glass door. **Blocked drainage strip. This may allow moisture ponding of water in the track and related conditions. Recommend repairs.**

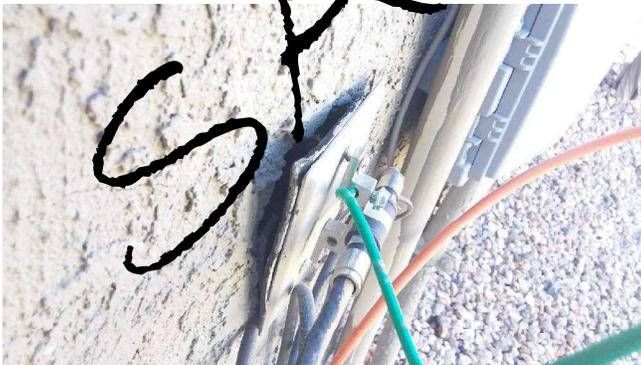
16. Exterior Lighting: Surface mount.
 17. Exterior Electric: 120V AC GFCI. **Loose or missing outlets / moisture cover. Recommend repairs to prevent moisture damage and pest intrusion.**

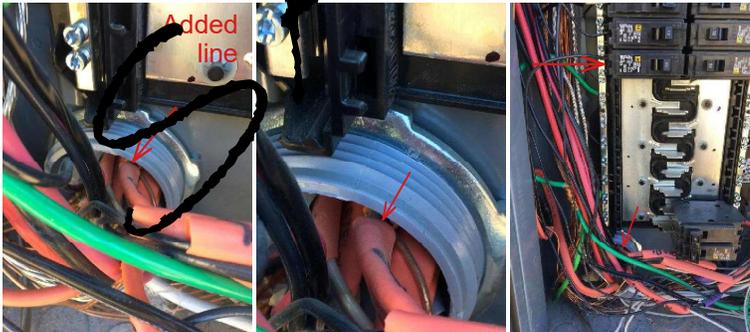
4. 240 VAC Branch Circuits(49): Copper and aluminum - **Tenant made reference to the stove popping the circuit breaker. It is our findings that a line was added to garage post construction that was installed through the seam seal conduit. This is not the typical installation process and damage may have occurred to other lines. Stove operated properly during inspection. Recommend further evaluation and repairs as necessary.**

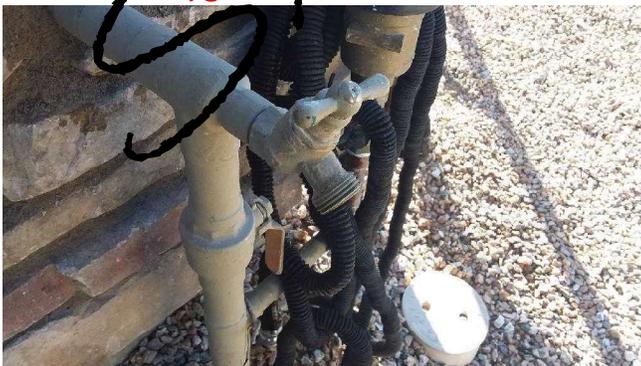
12. Cross Connections(35): Areas of Possible cross connections found. No anti siphons at hose bibs, Recommend upgrades. See DVW comments in this section for further issues.

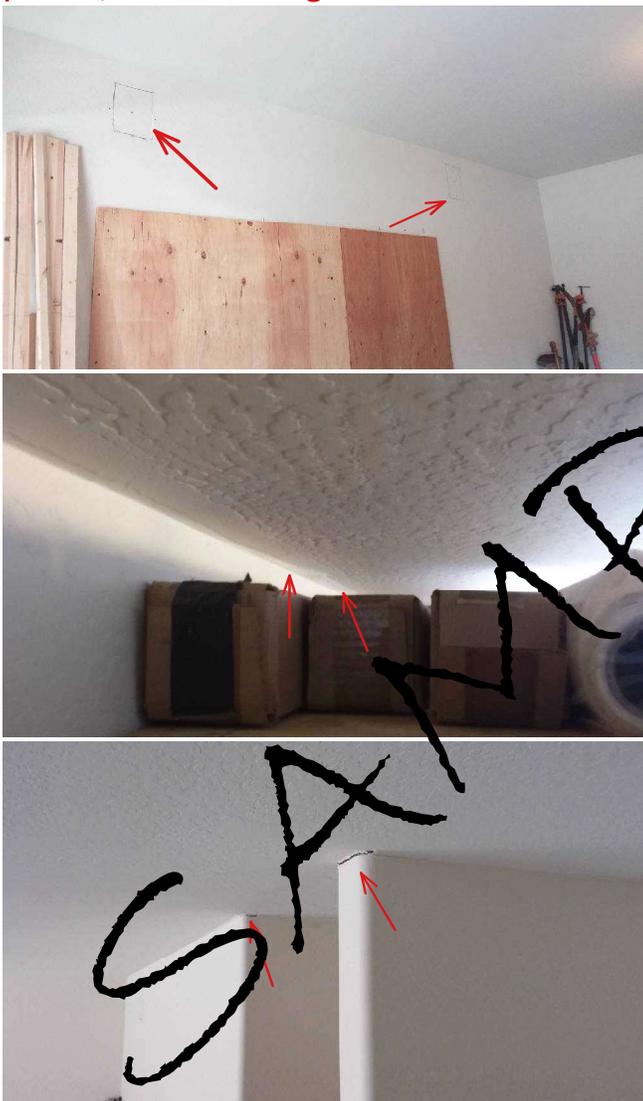
10. Walls fire separation(76): Painted drywall. **One or more openings noted. Recommend repairs with drywall material to restore Fire wall safety. (most caulking is not a fire rated material) . Signs of premature settlement cracks. Recommend repairs by a qualified competent professional and if persists, a structural engineer is recommended.**

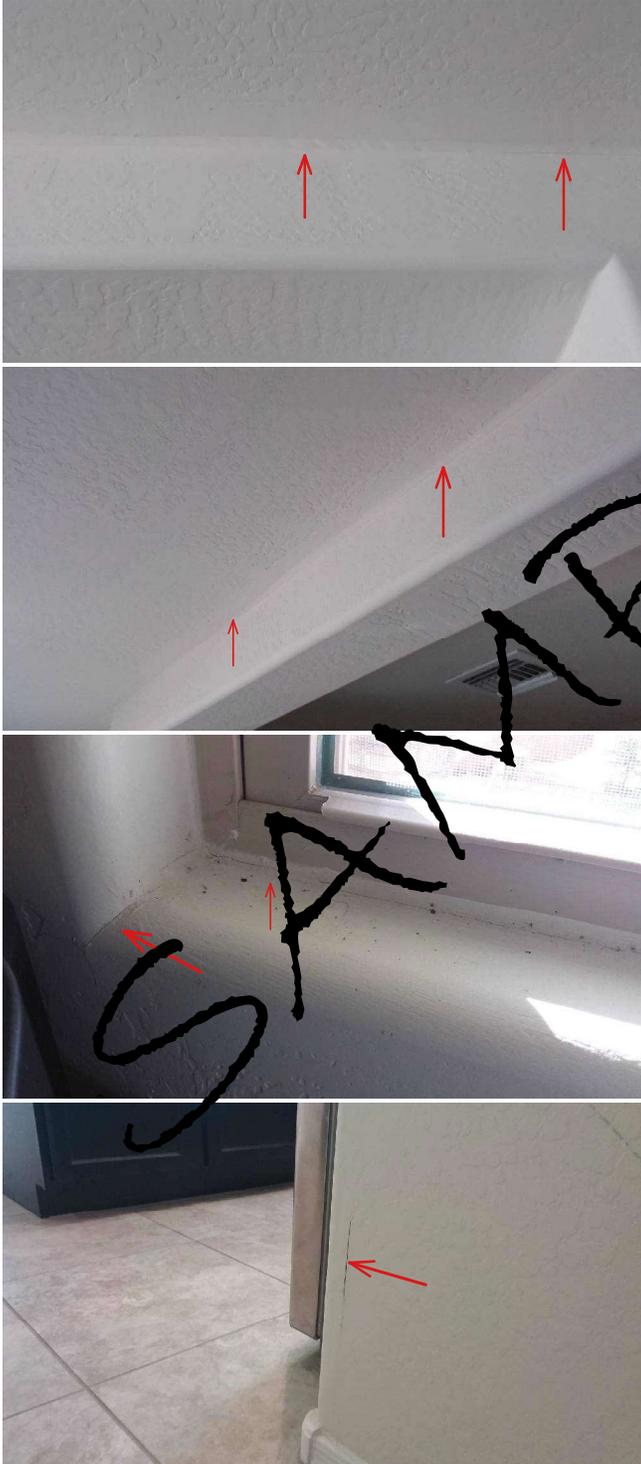
3. Walls(70): Painted drywall. **Premature Settlement cracks noted. Recommend repairs by a qualified competent professional and monitor. If persists recommend evaluation from structural engineer.**

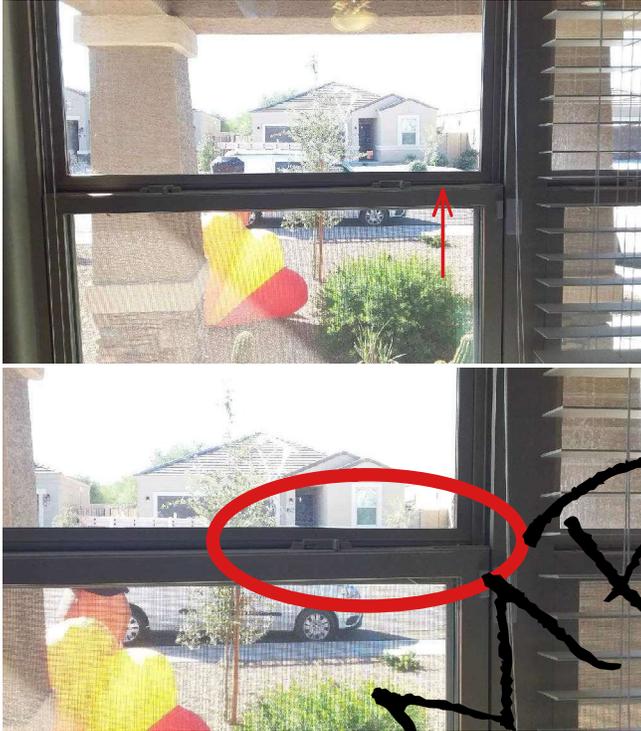
7. Windows(75): Double pane, vinyl frame. **Window in den is Unlevel in the casing. Appears to be operational at time of inspection. This can lead to hard operation and misalignment of the locks. Recommend evaluation and any necessary repairs by a qualified competent professional.**

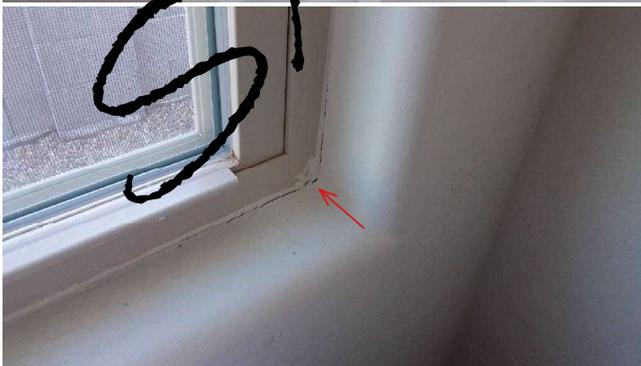
3. Walls(70): Painted drywall. **Premature Settlement cracks noted. Recommend repairs by a qualified competent professional and monitor. If persists recommend evaluation from structural engineer.**

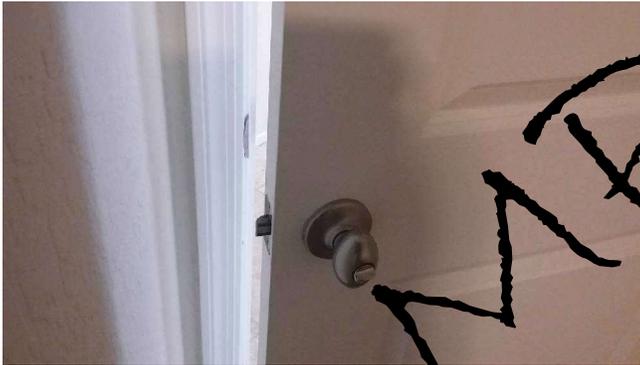
5. Doors(74): Interior hollow wood. Lock set(s) is not latching / functioning properly in left front room. Recommend evaluation and any necessary repairs by a qualified professional.

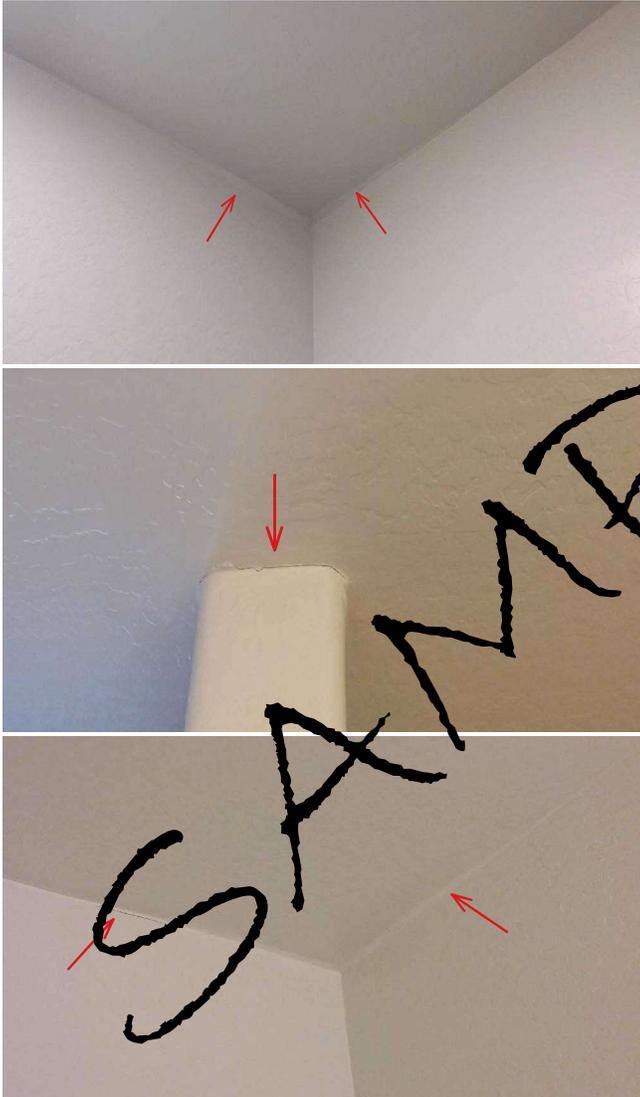
1. Closet: Single.
2. Ceiling(70): Painted drywall.
3. Walls(70): Painted drywall. **Premature settlement crack's noted. Recommend repairs by a qualified professional and monitor. If persists, recommended evaluation from structural engineer.**

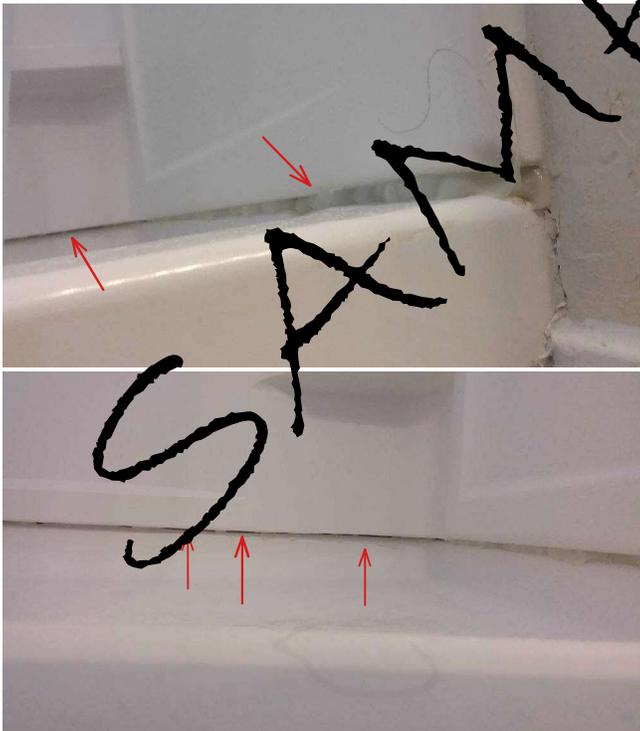
14. Shower/Surround: Fiberglass pan and fiberglass surround. Improper installation of master shower kit. This allows for large gaps around perimeter base. That will allow moisture to penetrate into building materials. Home owner was advised to just seal the gap. This has lead to improper sealing with holes that will still allow moisture to penetrate behind shower and no longer have any where to drain, causing related damages. It is our recommendation removing silicone and properly repairing/reinstalling.

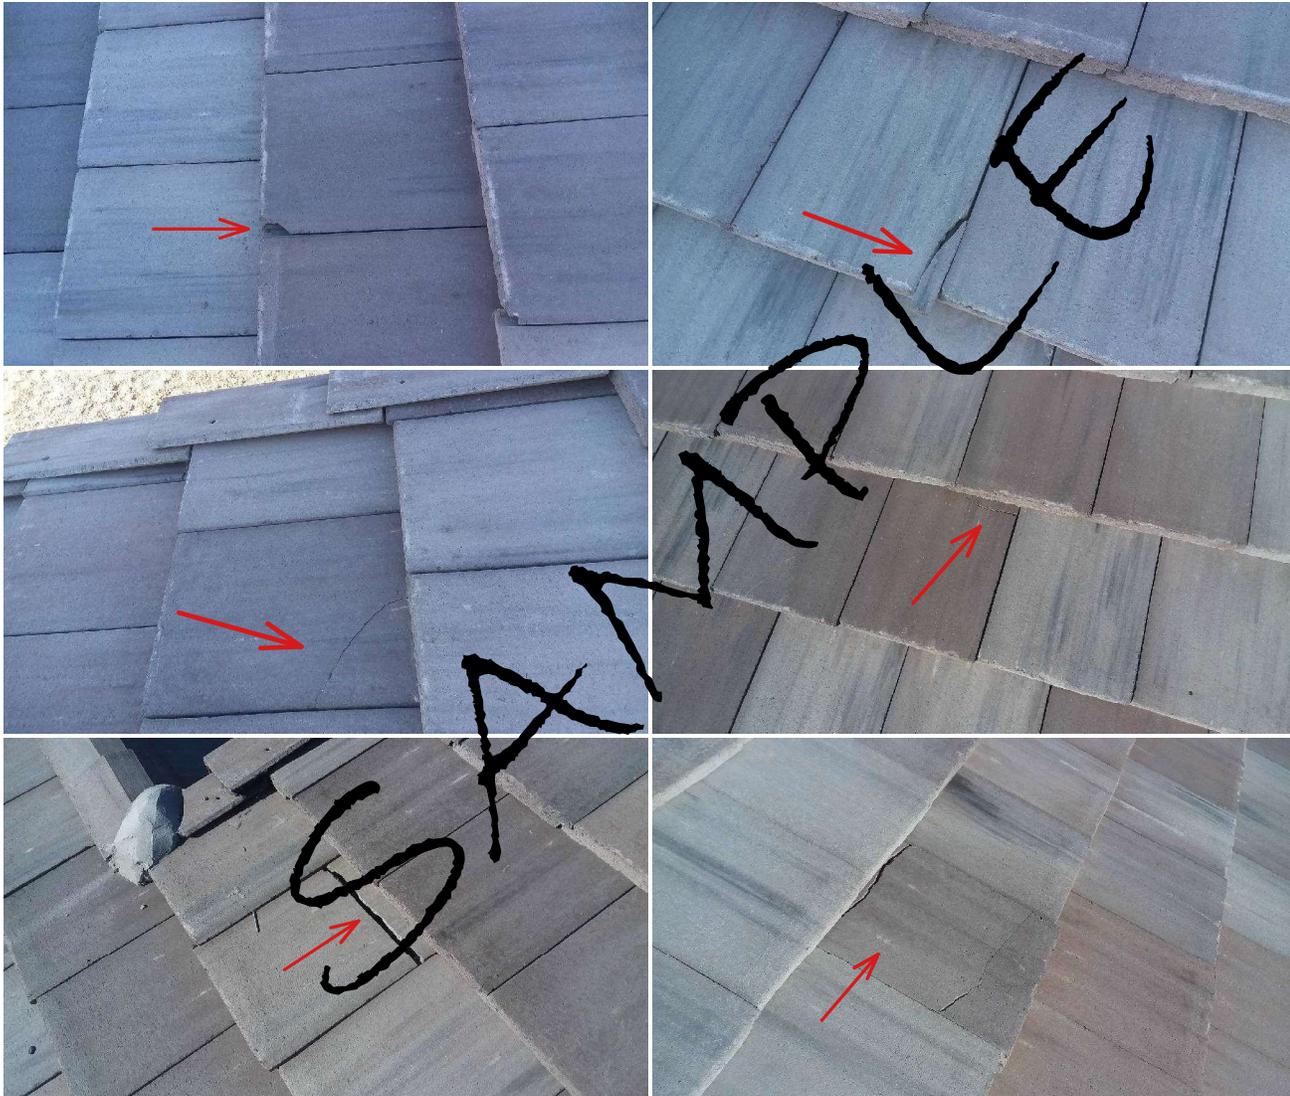
1. Roof Conditions: Repairs necessary. - **Loose/displaced/damaged shingles were found in one or more location. Recommend evaluation and any necessary repairs by a qualified professional.**

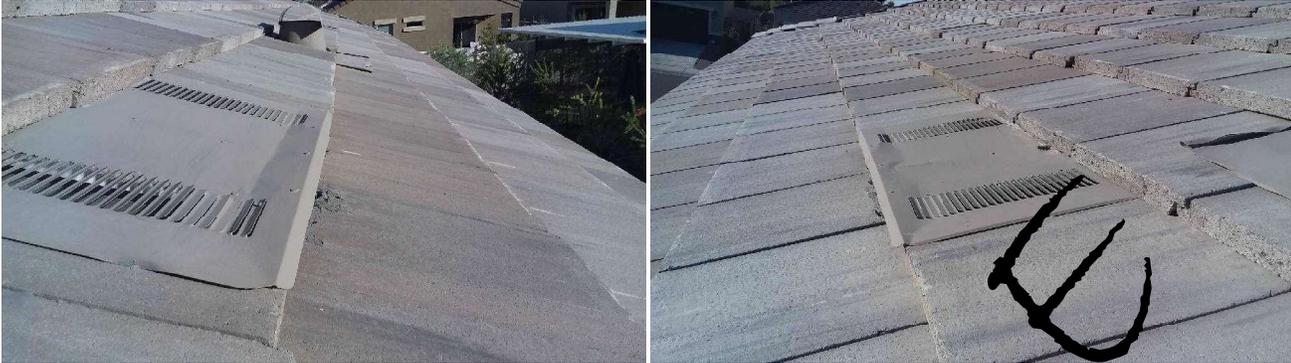
2. Roof Venting: Gable vent., Covered roof vents. **Vent hood is dented / damaged. This may allow for ponding and moisture penetration at damaged louver. Recommend evaluation and any necessary repairs by a qualified professional.**

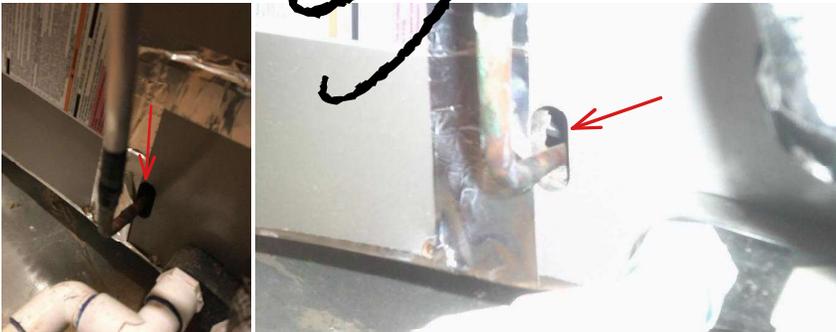
4. Main unit is in, Attic. Heating System Devices: Furnace / air handler Cabinet. **Holes / openings in cabinet noted. Allowing conditioned air to escape into attic location. Recommend evaluation and any necessary repairs by a qualified professional.**

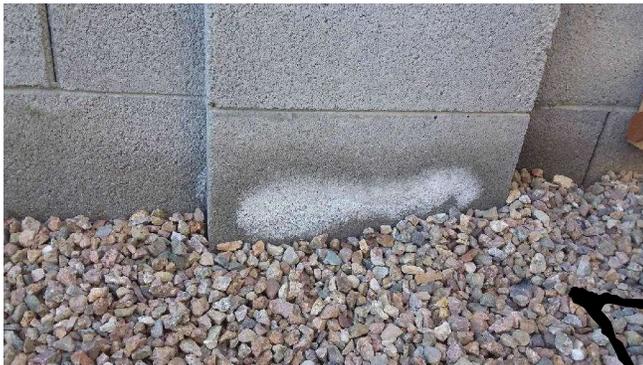
6. Fences: Block fence with split rail metal gate with wood plank - Efflorescence was noted. This is a condition due to moisture. Recommend following up with neighbors for plant watering along fence line. Recommend monitor/maintain and repair as necessary.

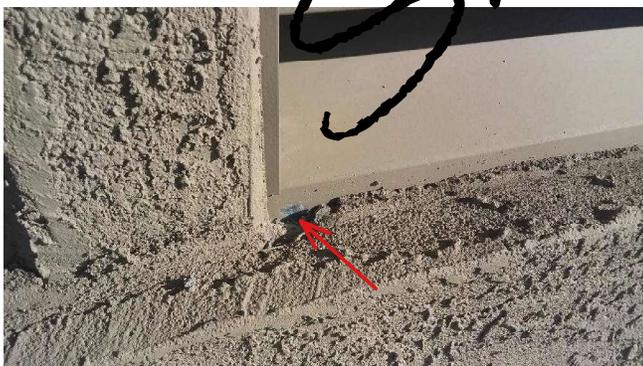
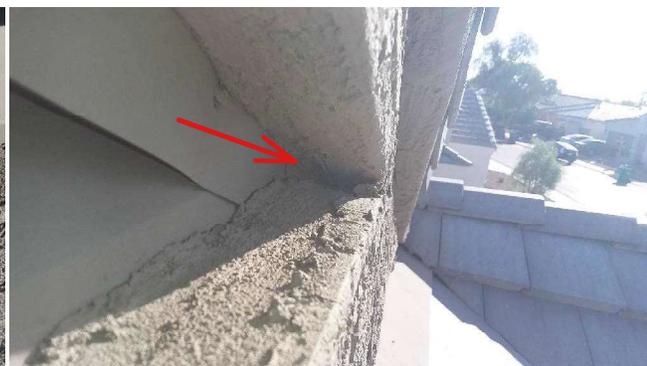
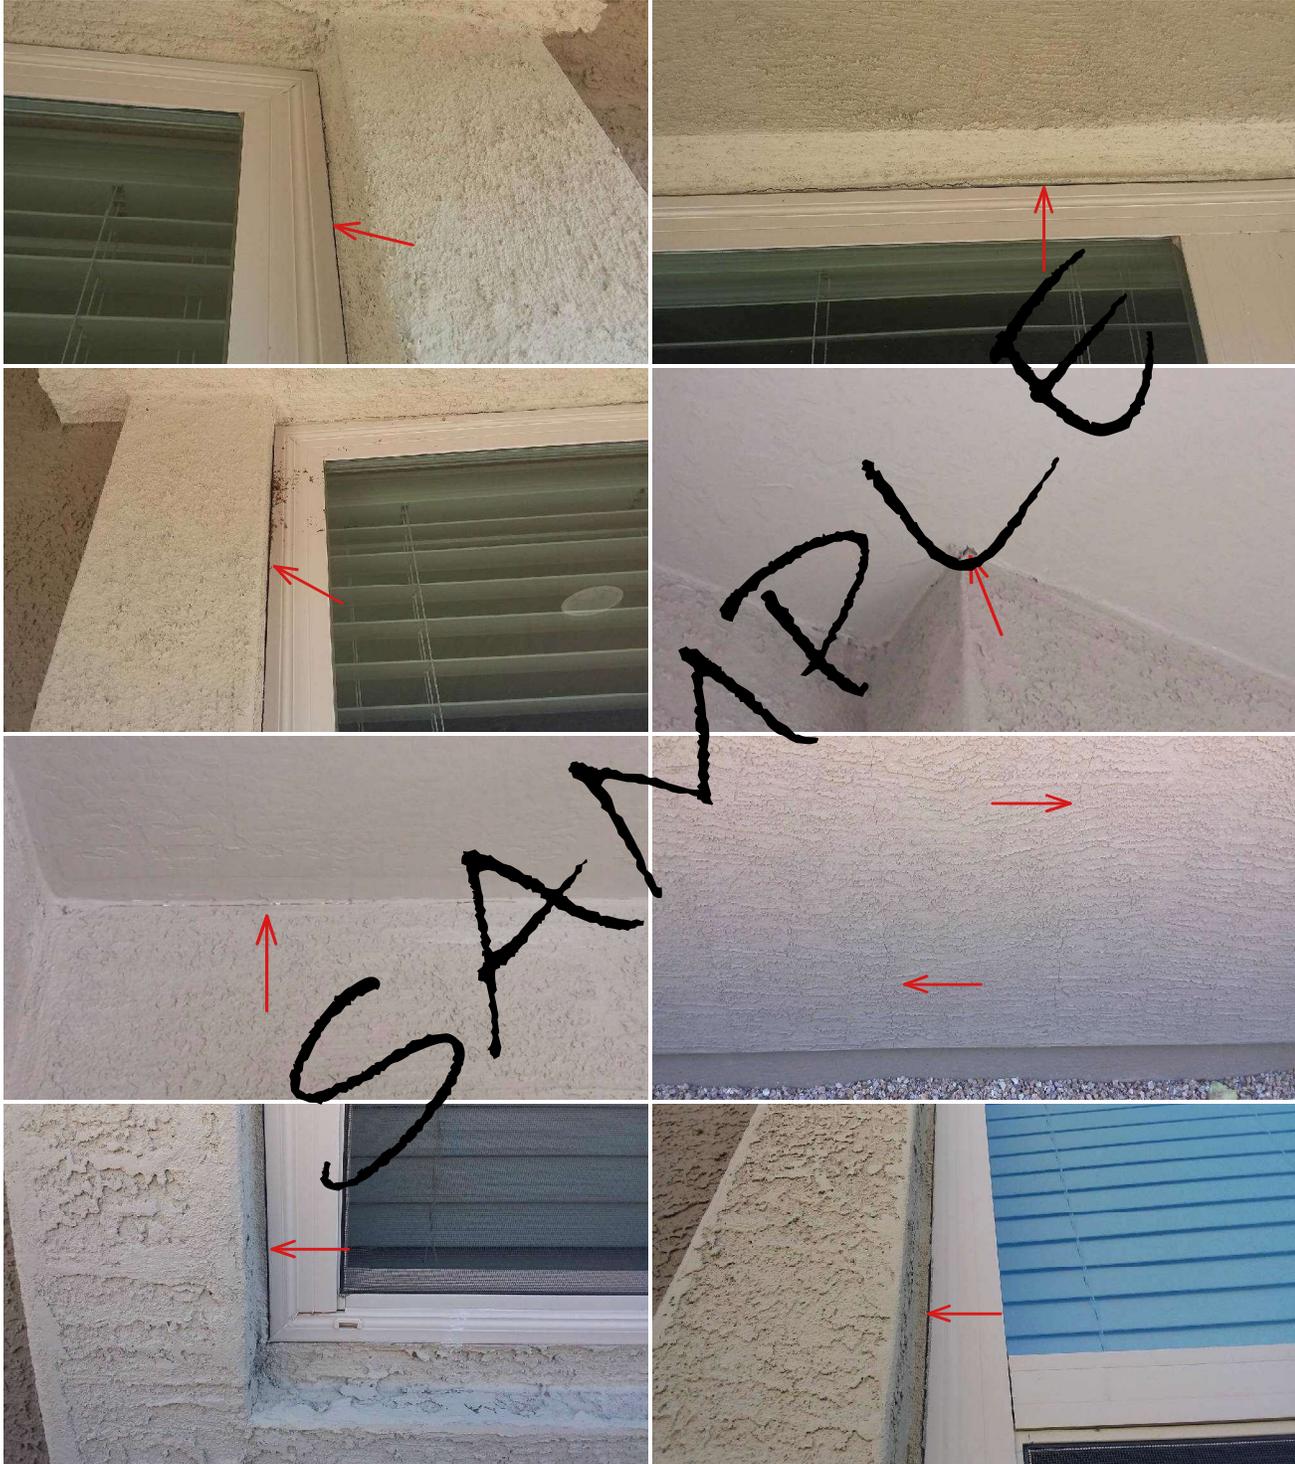
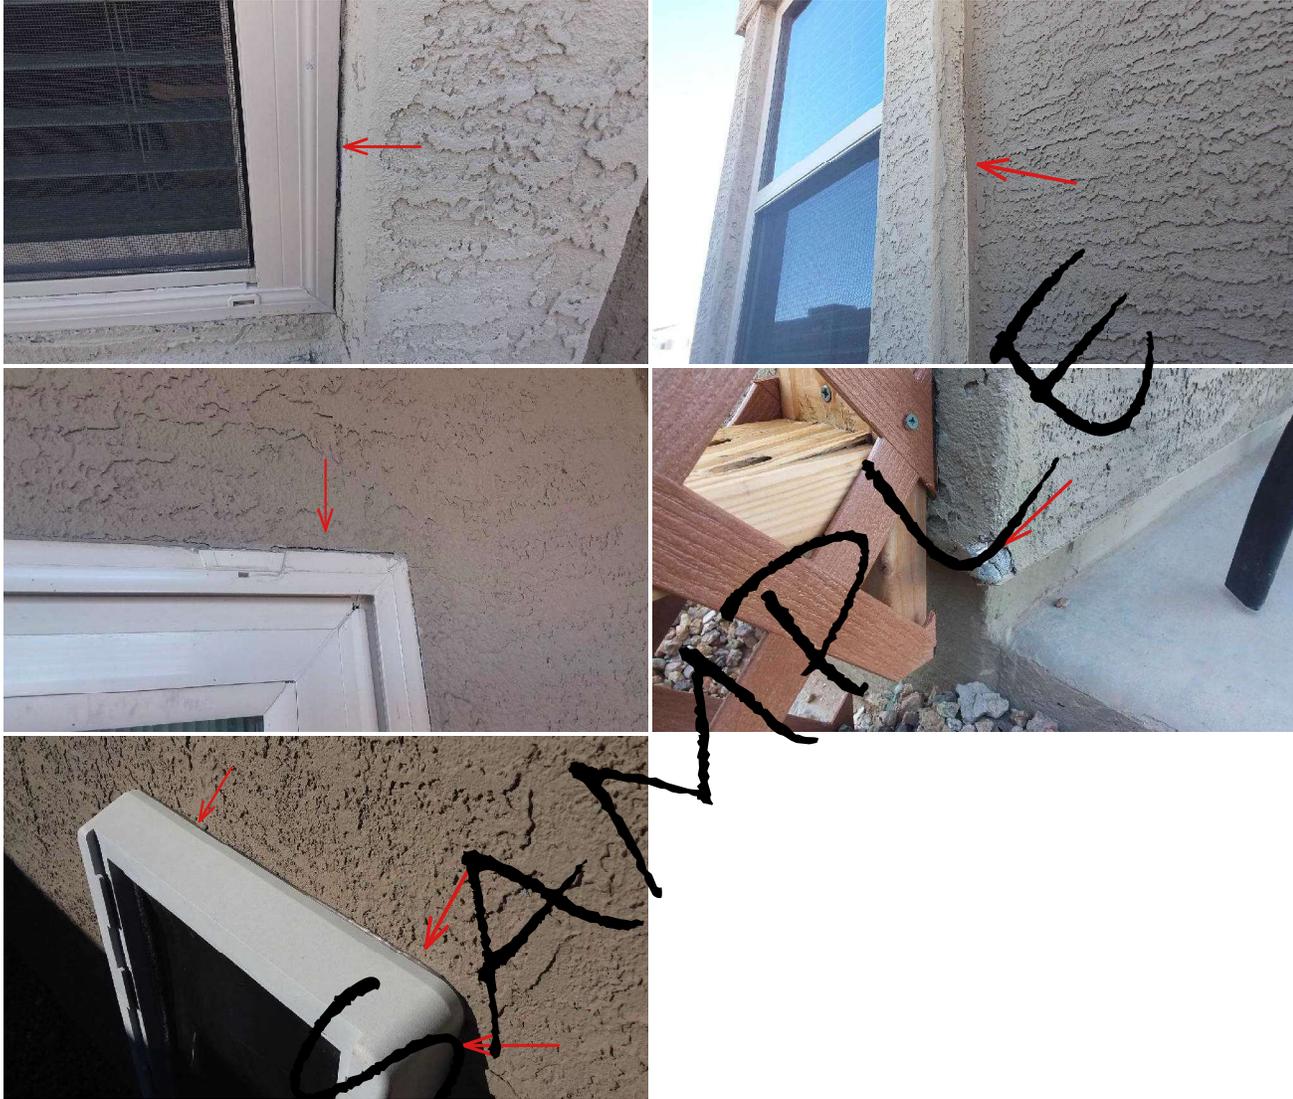
7. Cladding Conditions: Multiple conditions noted. Cracks and openings in need of repair to prevent water and pest intrusion. Dog door was not properly sealed during inspection and may allow moisture penetration. Signs of premature settlement cracks noted. Recommend evaluation and any necessary repairs by a qualified professional.

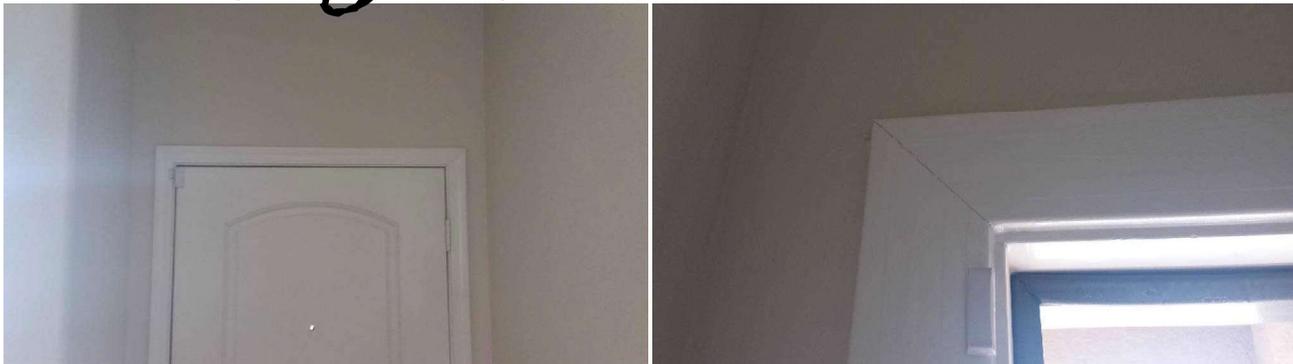
8. Entry Doors(15): Metal, Wood, Glass. **Settlement noted around trim and door is Unlevel in frame. Recommend evaluation and any necessary repairs by a qualified professional.**

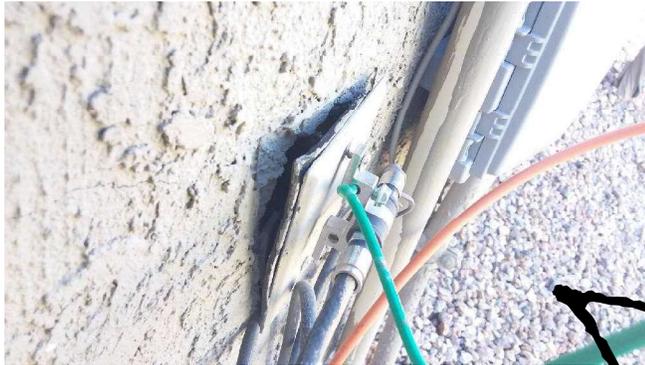
10. Exterior Electric: 120 VAC GFCI. **Loose or missing outlets / moisture cover. Recommend repairs to prevent moisture damage and pest intrusion.**

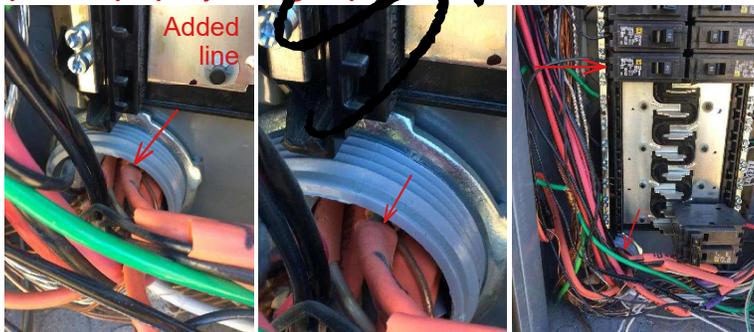
11. 240 VAC Branch Circuits(49): Copper and aluminum - **Tenant made reference to the stove popping the circuit breaker. It is our findings that a line was added to garage post construction that was installed through the foam seal conduit. This is not the typical installation process and damage may have occurred to other lines. Stove operated properly during inspection. Recommend further evaluation and repairs as necessary.**

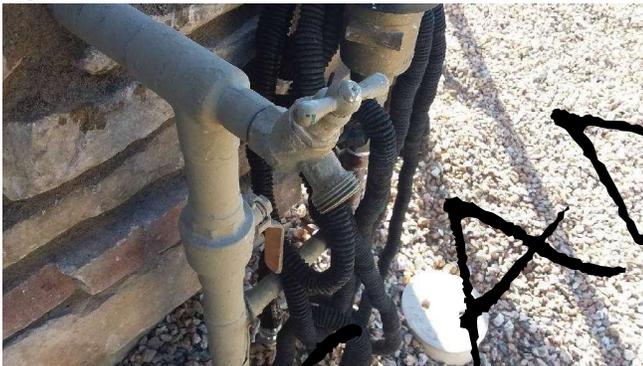
13. Cross Connections(35): Areas of Possible cross connections found. No anti siphons at hose bibs, Recommend upgrades. See DVW comments in this section for further issues.

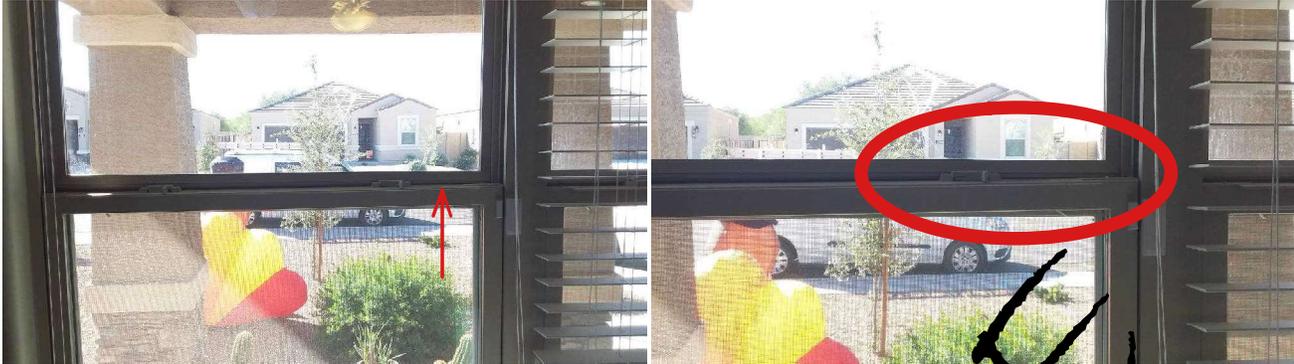
17. Den., Dining Room., Living Room., Hallway(s) Living Space Windows(75): Double pane, vinyl frame. **Window in den is Unlevel in the casing. Appears to be operational at time of inspection. This can lead to hard operation and misalignment of the locks. Recommend evaluation and any necessary repairs by a qualified competent professional.**

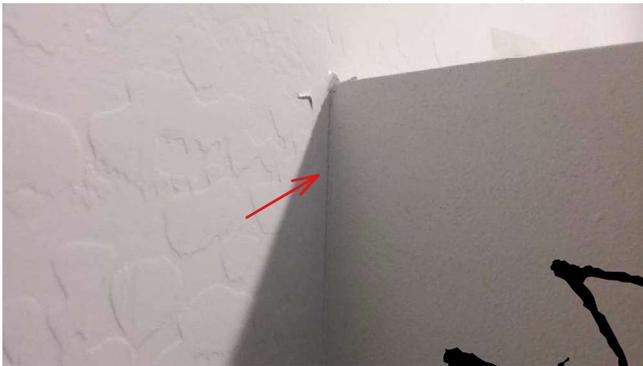
18. Master. Left front and middle. Bedroom Closet: Standard. - **Shelving / supports separating from wall in master. Recommend evaluation and any necessary repairs by a qualified professional.**

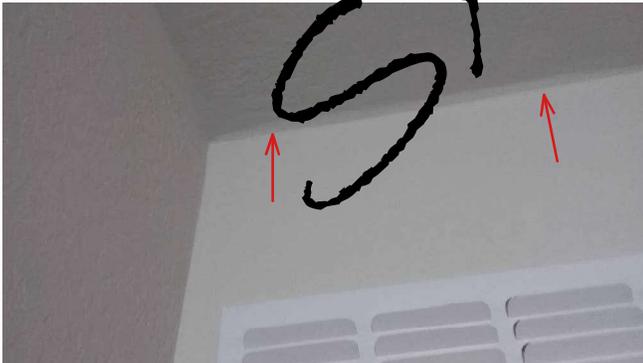
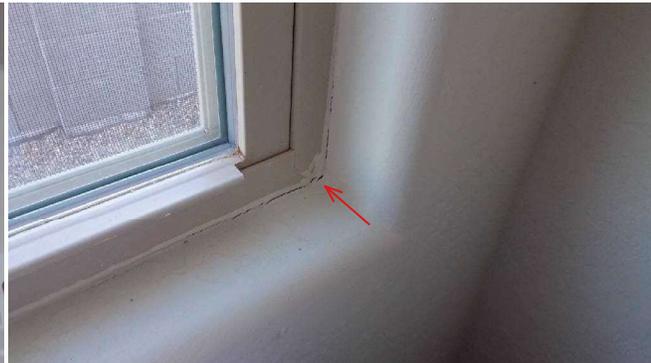
19. Master. Left front and middle. Bedroom Walls(70): Painted drywall. **Premature Settlement cracks noted. Recommend repairs by a qualified competent professional and monitor. If persists recommend evaluation from structural engineer.**

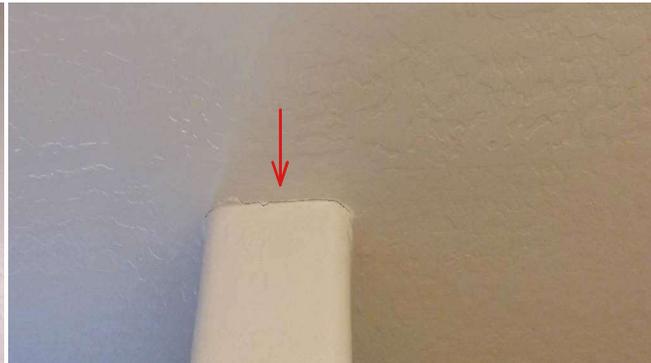
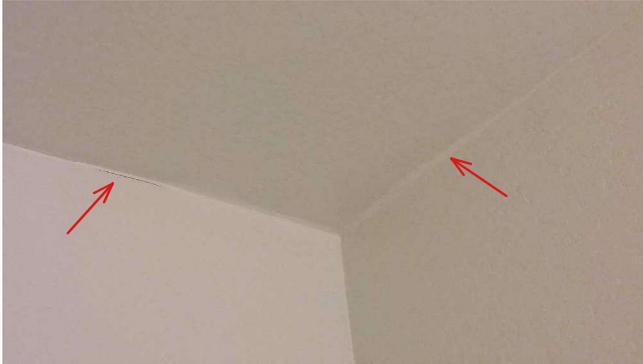
21. Master location., Main area. Bathroom Walls(70): Painted drywall. Premature settlement crack's noted. Recommend repairs by a qualified professional and monitor. If persists, recommended evaluation from structural engineer.

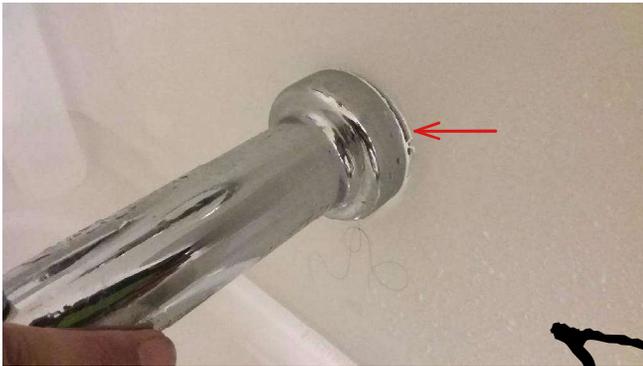
22. Master location., Main area. Bathroom Tub/Surround: Fiberglass tub and fiberglass surround. **Spout gap present in main bathroom. Recommend sealing and monitoring to prevent moisture damage.**

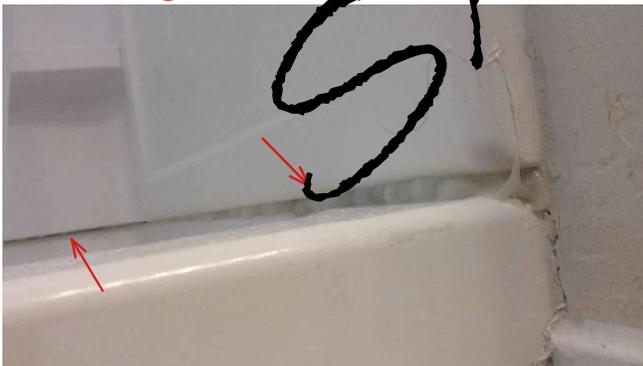
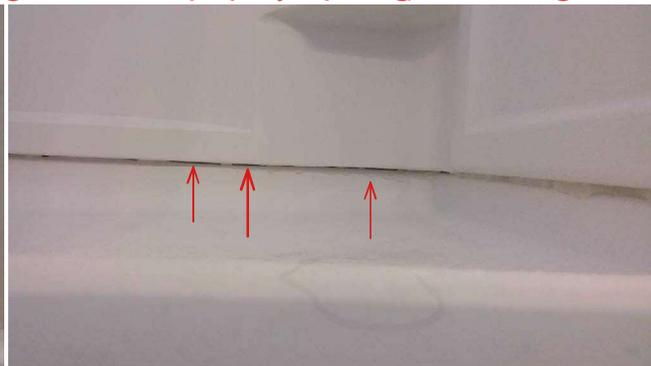
23. Master location., Main area. Bathroom Shower/Surround: Fiberglass pan and fiberglass surround. **Improper installation of master shower kit. This allows for large gaps around perimeter base. That will allow moisture to penetrate into building materials. Home owner was advised to just seal the gap. This has lead to improper sealing with holes that will still allow moisture to penetrate behind shower and no longer have any where to drain, causing related damages. It is our recommendation removing silicone and properly repairing/ reinstalling.**
