Halo Home
Inspections

Home Inspection Report

12345 Resale Ave
Maricopa,, AZ 85138.

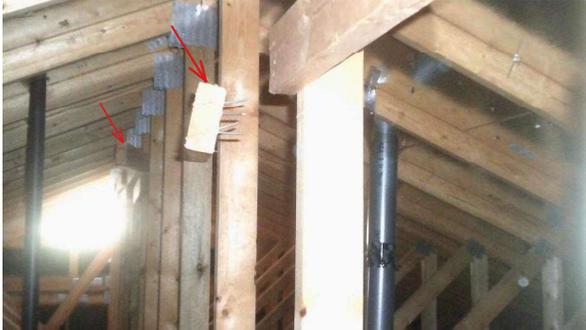
4. Roof Framing: 2x4 Rafter., 2x4 Truss cord., 2x6 Joist. **One or more support ties are damaged / displaced. Recommend evaluation and necessary repairs by qualified professional.**

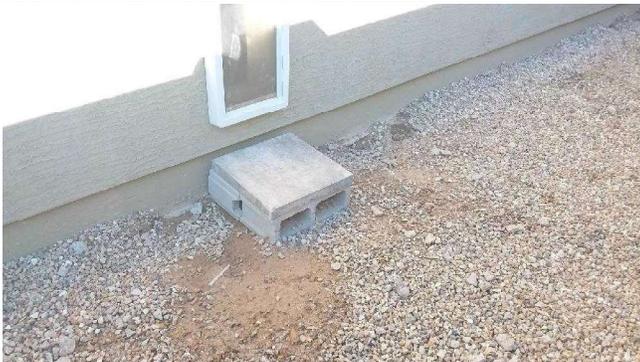
14. Grading(22): Minor slope. **One or more sinkhole(s) / Low spots were found. Recommend dirt be added to prevent pooling and further erosion. This promotes foundation deterioration and pest intrusion and needs correction and monitoring. .**

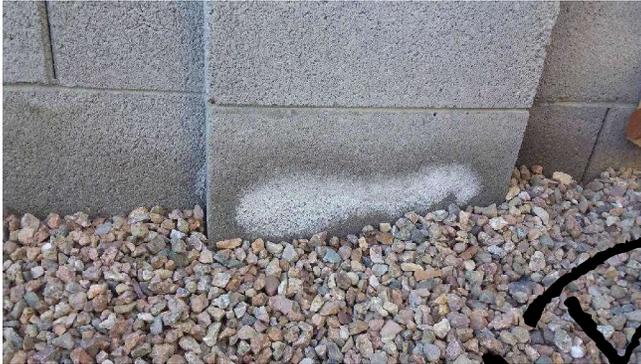
15. Swale:
16. Vegetation(21): Shrubs and Trees.
17. Lawn/Boarders Gravel .
18. Window Wells:
19. Retaining Walls/Planters(24):
20. Exterior Surface Drain:
21. Fences: Block fence with split rail metal gate with wood plank - **Efflorescence was noted. This is a condition due to moisture. Recommend following up with neighbors for plant watering along fence line. Recommend monitor/maintain and repair as necessary.**

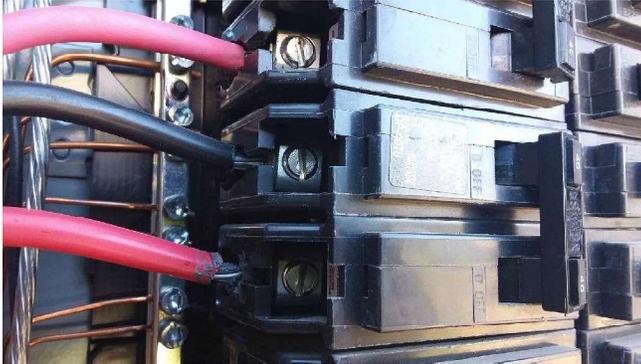
4. 240 VAC Branch Circuits(49): Copper and aluminum - **Tenant made reference to the stove popping the circuit breaker. It is our findings that a line was added to garage post construction that was installed through the seam seal conduit. This is not the typical installation process and damage may have occurred to other lines. Stove operated properly during inspection. Recommend further evaluation and repairs as necessary.**

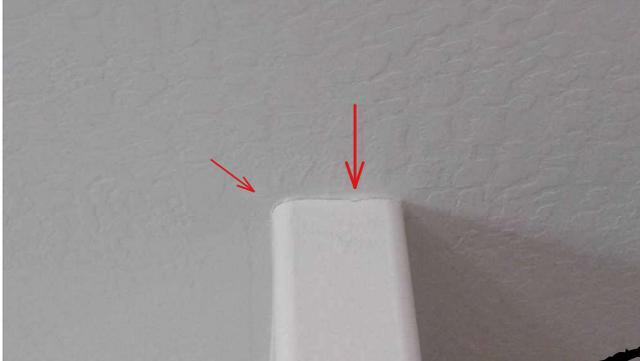
18. Counter Tops(73): Granite.
19. Cabinets(73): Composite material and wood.
20. Pantry: Single., Wall shelves.
21. Ceiling(70): Painted drywall.
22. Walls(70): Painted drywall. **Premature Settlement cracks noted. Recommend repairs by a qualified competent professional and monitor. If persists recommend evaluation from structural engineer.**

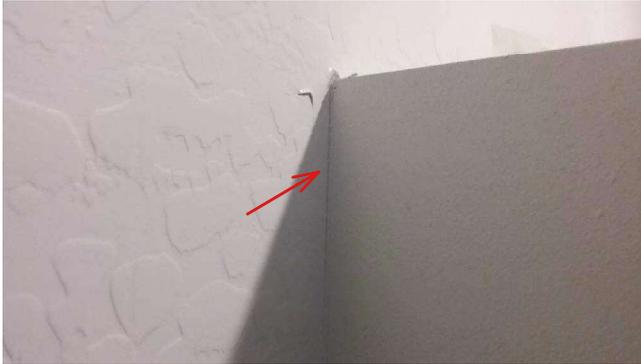
1. Closet: Standard. - **Shelving / supports separating from wall in master. Recommend evaluation and any necessary repairs by a qualified professional.**

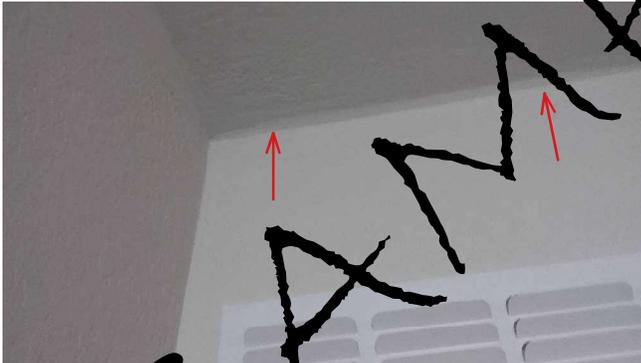
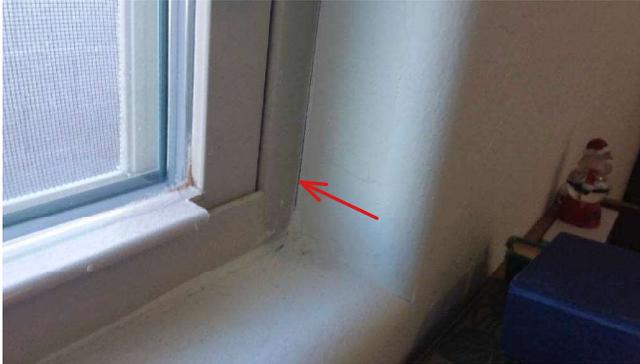
3. Walls(70): Painted drywall. **Premature Settlement cracks noted. Recommend repairs by a qualified competent professional and monitor. If persists recommend evaluation from structural engineer.**

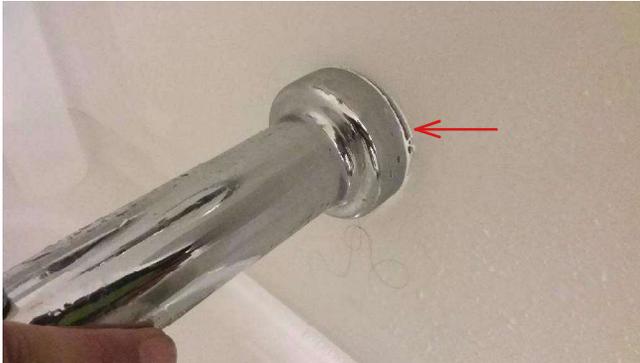
13. Tub/Surround: Fiberglass tub and fiberglass surround. Spout gap present in main bathroom. Recommend sealing and monitoring to prevent moisture damage.

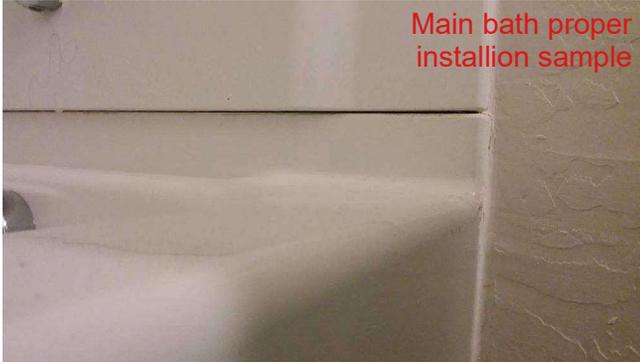
14. Shower/Surround: Fiberglass pan and fiberglass surround. Improper installation of master shower kit. This allows for large gaps around perimeter base. That will allow moisture to penetrate into building materials. Home owner was advised to just seal the gap. This has lead to improper sealing with holes that will still allow moisture to penetrate behind shower and no longer have any where to drain, causing related damages. It is our recommendation removing silicone and properly repairing/reinstalling.

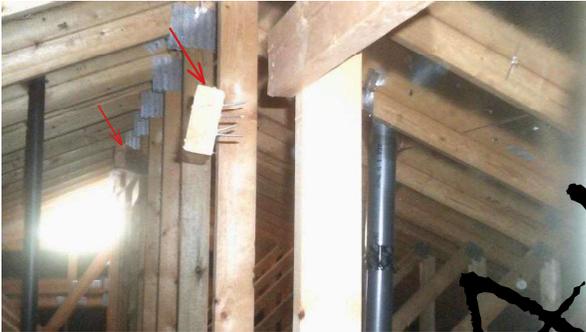
3. Main access located at, Laundry room. Attic Roof Framing: 2x4 Rafter., 2x4 Truss cord., 2x6 Joist. **One or more support ties are damaged / displaced. Recommend evaluation and necessary repairs by qualified professional.**

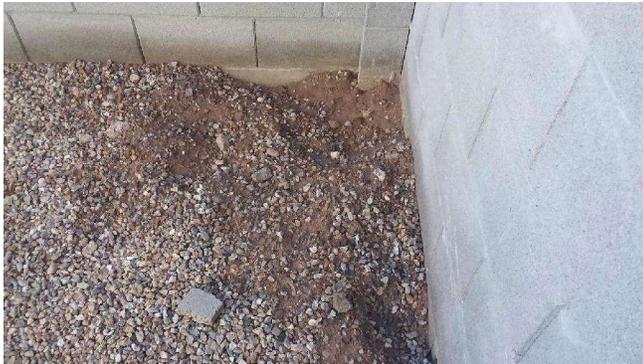
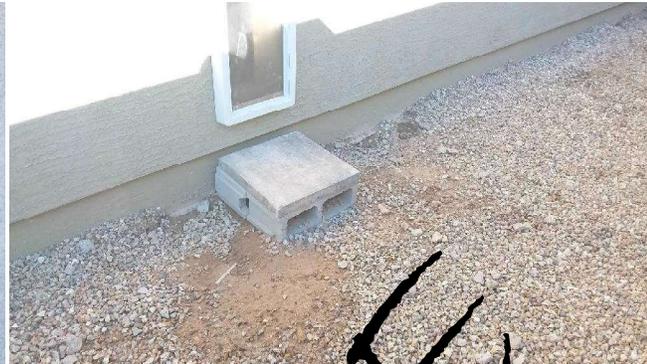
Grading(22): (continued)

5. Grading(22): Minor slope. **One or more sinkhole(s) / Low spots were found. Recommend dirt be added to prevent ponding and further erosion. This promotes foundation deterioration and pest intrusion and needs correction and monitoring. .**

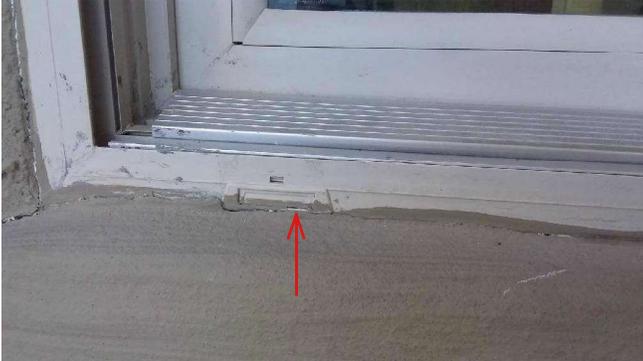
9. Patio Door: Sliding glass door. **Blocked drainage strip. This may allow moisture ponding of water in the track and related conditions. Recommend repairs.**

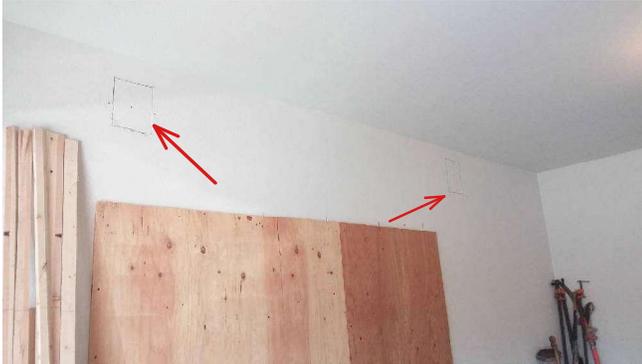
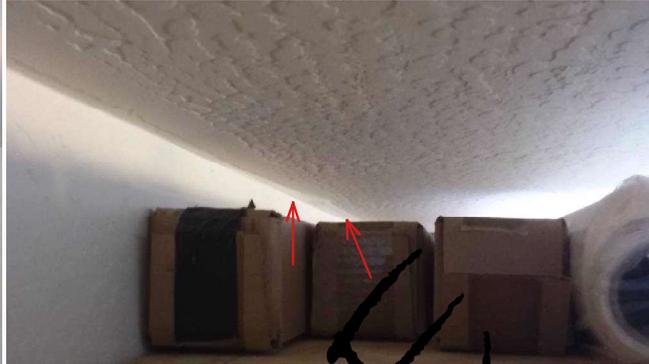
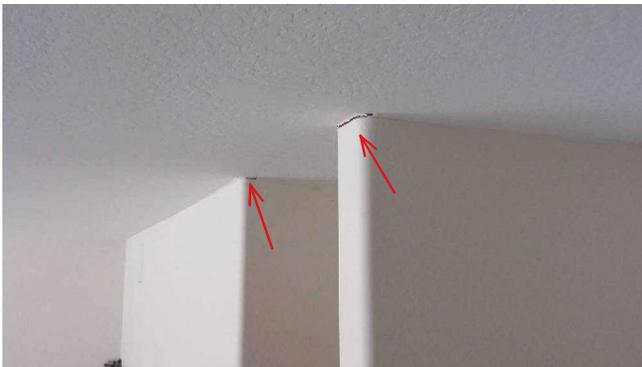
Walls fire separation(76): (continued)

14. Attached. Garage Walls fire separation(76): Painted drywall. One or more openings noted. Recommend repairs with drywall material to restore Fire wall safety. (most caulking is not a fire rated material) . Signs of premature settlement cracks. Recommend repairs by a qualified competent professional and if persists, a structural engineer is recommended.

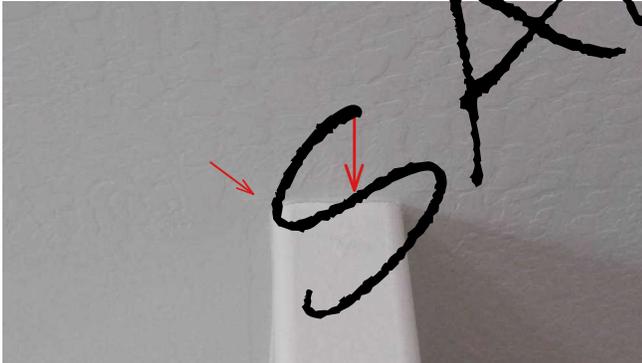
15. 1st Floor. Kitchen Walls(70): Painted drywall. **Premature Settlement cracks noted. Recommend repairs by a qualified competent professional and monitor. If persists recommend evaluation from structural engineer.**

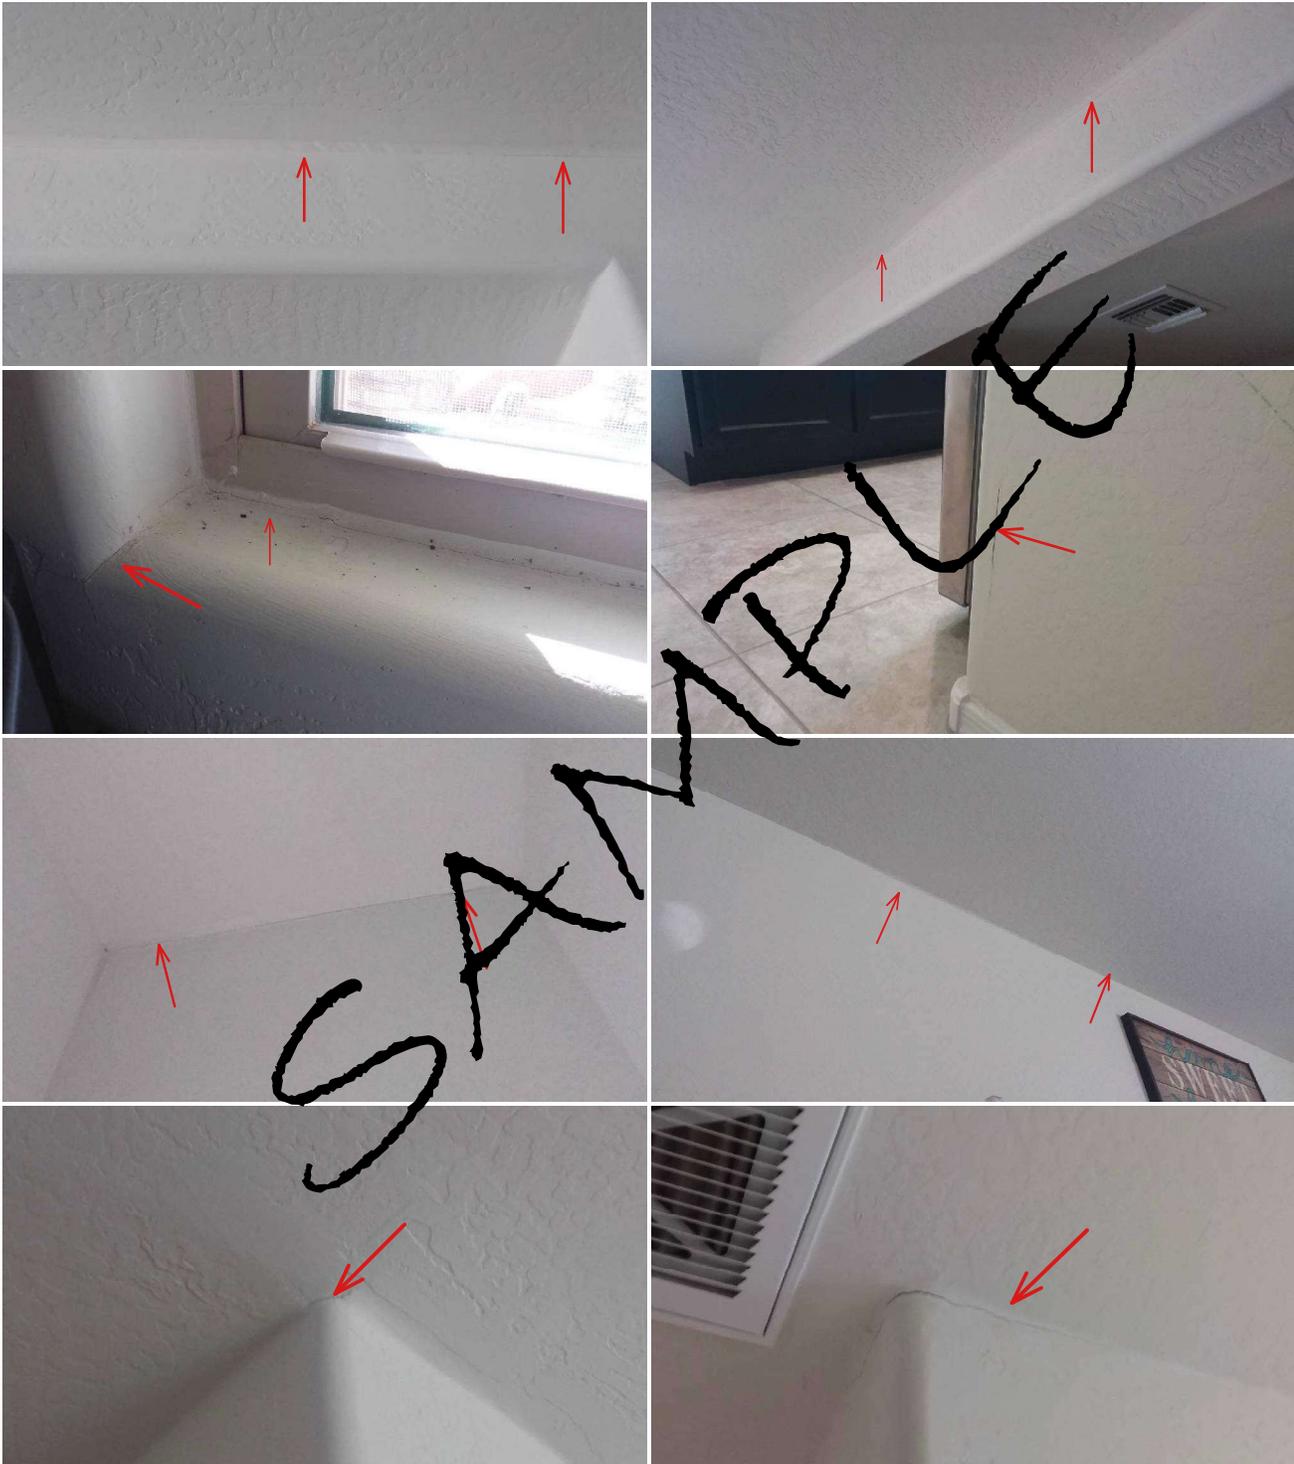
Walls(70): (continued)

16. Den., Dining Room., Living Room., Hallway(s) Living Space Walls(70): Painted drywall. **Premature Settlement cracks noted. Recommend repairs by a qualified competent professional and monitor. If persists recommend evaluation from structural engineer.**

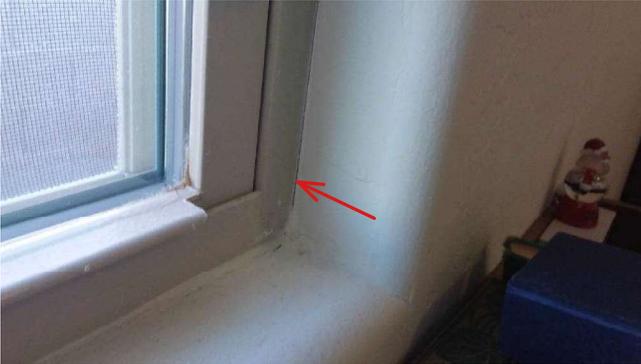
Walls(70): (continued)

19. Master. Left front and middle. Bedroom Walls(70): Painted drywall. **Premature Settlement cracks noted. Recommend repairs by a qualified competent professional and monitor. If persists recommend evaluation from structural engineer.**

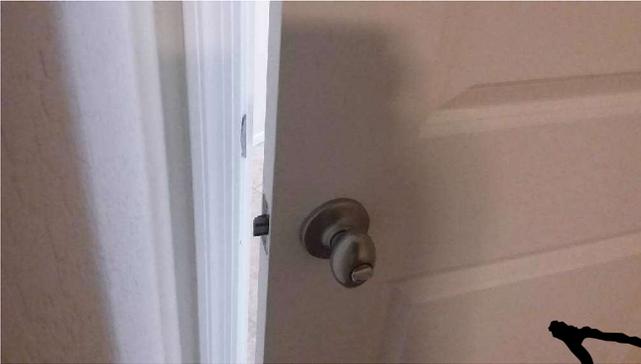
20. Master. Left front and middle. Bedroom Doors(74): Interior hollow wood. Lock set(s) is not latching / functioning properly in left front room. Recommend evaluation and any necessary repairs by a qualified professional.

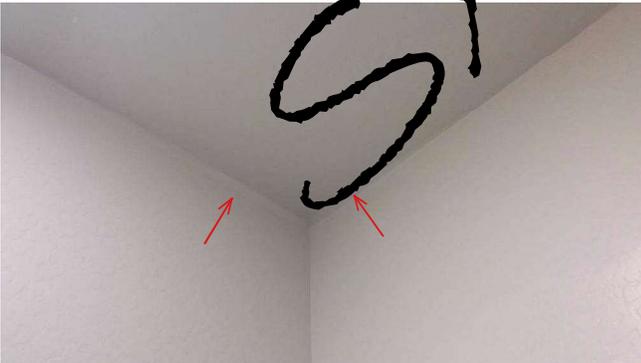
21. Master location., Main area. Bathroom Walls(70): Painted drywall. Premature settlement crack's noted. Recommend repairs by a qualified professional and monitor. If persists, recommended evaluation from structural engineer.

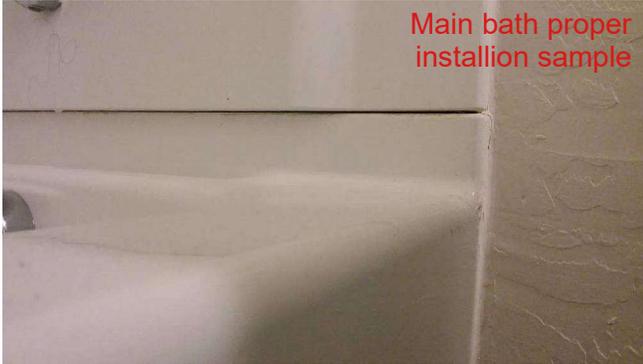
Shower/Surround: (continued)

23. Master location., Main area. Bathroom Shower/Surround: Fiberglass pan and fiberglass surround. **Improper installation of master shower kit. This allows for large gaps around perimeter base. That will allow moisture to penetrate into building materials. Home owner was advised to just seal the gap. This has lead to improper sealing with holes that will still allow moisture to penetrate behind shower and no longer have any where to drain, causing related damages. It is our recommendation removing silicone and properly repairing/ reinstalling.**

Main bath proper
installion sample
